**STONE W. BACHMAN, BOARD CERTIFIED ENTOMOLOGIST**  
**REPORT OF STRUCTURAL PEST INSPECTION AND CASE REVIEW**  
**ISSUE DATE: 25 JANUARY 2026**

The TRADEWINDS located at Tradewinds Trace, Hilton Head Island, SC, was inspected on January 5th and 6th, 2026, by the above-listed Inspector. This report details the inspection findings regarding wood-destroying organisms (WDOs), their damage, and control. This report may also, if necessary, assign conclusions to those findings.

The Tradewinds is a multi-housing complex of seven structures (including the pool house) and consists of twenty-eight individual housing units.

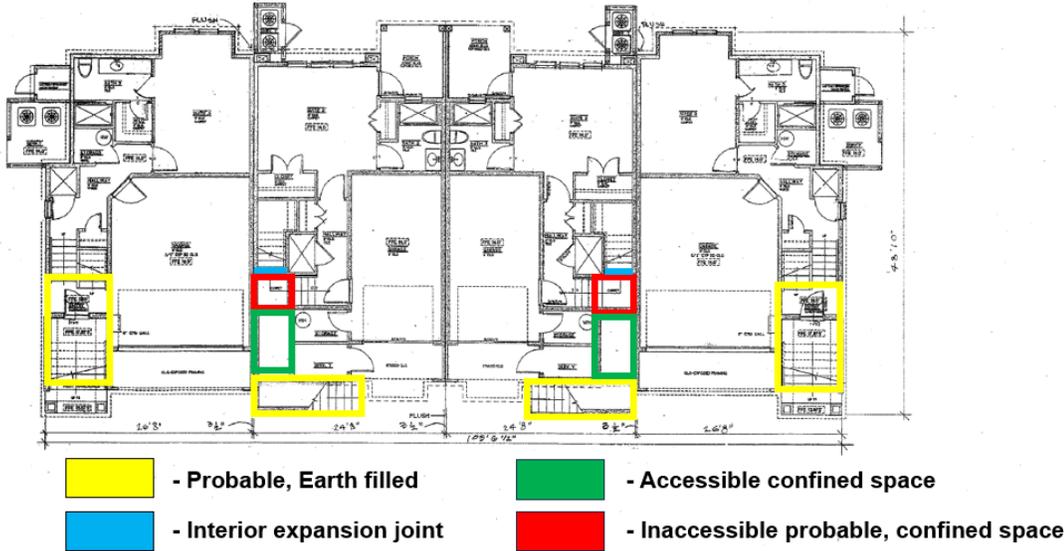
Exhibit 1.

This inspection was based upon visible evidence in readily accessible areas. All references to direction in this report are given from and facing the front of the structures. Accessible interiors, exteriors, attics, and accessible confined spaces of the structure were inspected. A review and analysis of documentation related to construction design and WDOs was also conducted. Exhibit 1 is used as a general reference and design for each building.

There also appear to be inaccessible confined spaces and interior expansion joints in the units inspected (see Exhibit 1). These construction components appear to be a feature of every condominium unit. These features increase the probability of a subterranean termite infestation and should be addressed as a function of an adequate subterranean termite treatment.

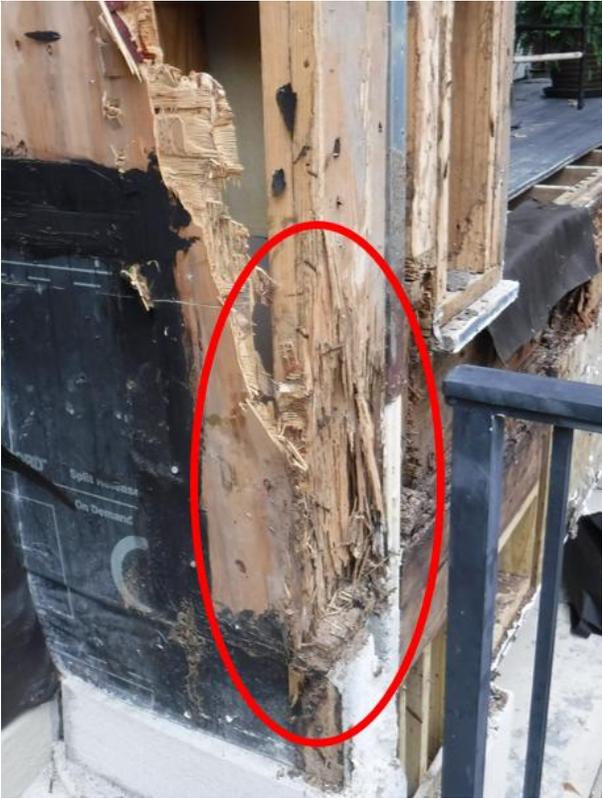
Exhibit 2.

The inspection observed subterranean termite damage to the garage header on unit 10-4 (exhibit 2). Subterranean termite activity was also discovered on the garage header of unit 10-1 (exhibit 3). The damage/activity was adjacent to a front, probably earth-filled landing (see exhibit 1). **The probable, earth-filled structures appear not to have been treated and/or partially treated during post-construction subterranean termite treatment(s).** These infestations appear to be ground-based.

Due to the previous discovery of carton material, these infestations appear to be those of the Formosan subterranean termite. Formosan subterranean termites require moisture for survival and can establish aerial colonies without contact with the ground when moisture is high. Also, Formosans can create above-ground colonies by accessing moisture through structural faults. Formosans can build carton-type material in areas with elevated moisture conditions within the structure and then discontinue contact with the ground. It is important to eliminate all sources of moisture caused by structural faults. It is the opinion of this Inspector that the Formosan subterranean termite infestation and damage was the direct result of an ongoing ground infestation due to improperly treated probable, earth-filled landings. It also appears that these infestations were associated with moisture infiltration caused by construction defects and/or maintenance issues.

Due to the unknown treatment history of the structures and the observation of subterranean termite damage, it is recommended that **a full conventional subterranean termite treatment** be performed using an approved non-repellent termiticide. See attachment for a description of the recommended treatment.

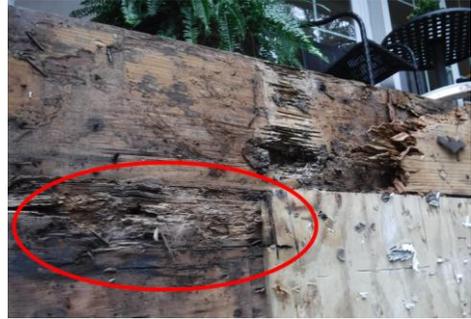
Exhibit 4.

Wood decay fungi damage (commonly known as wood rot) was observed on the garage header on unit 10-4 (exhibit 4). Wood rot becomes active when wood moisture readings reach 28%, and its presence indicates a structural fault caused by construction defects and/or maintenance issues.

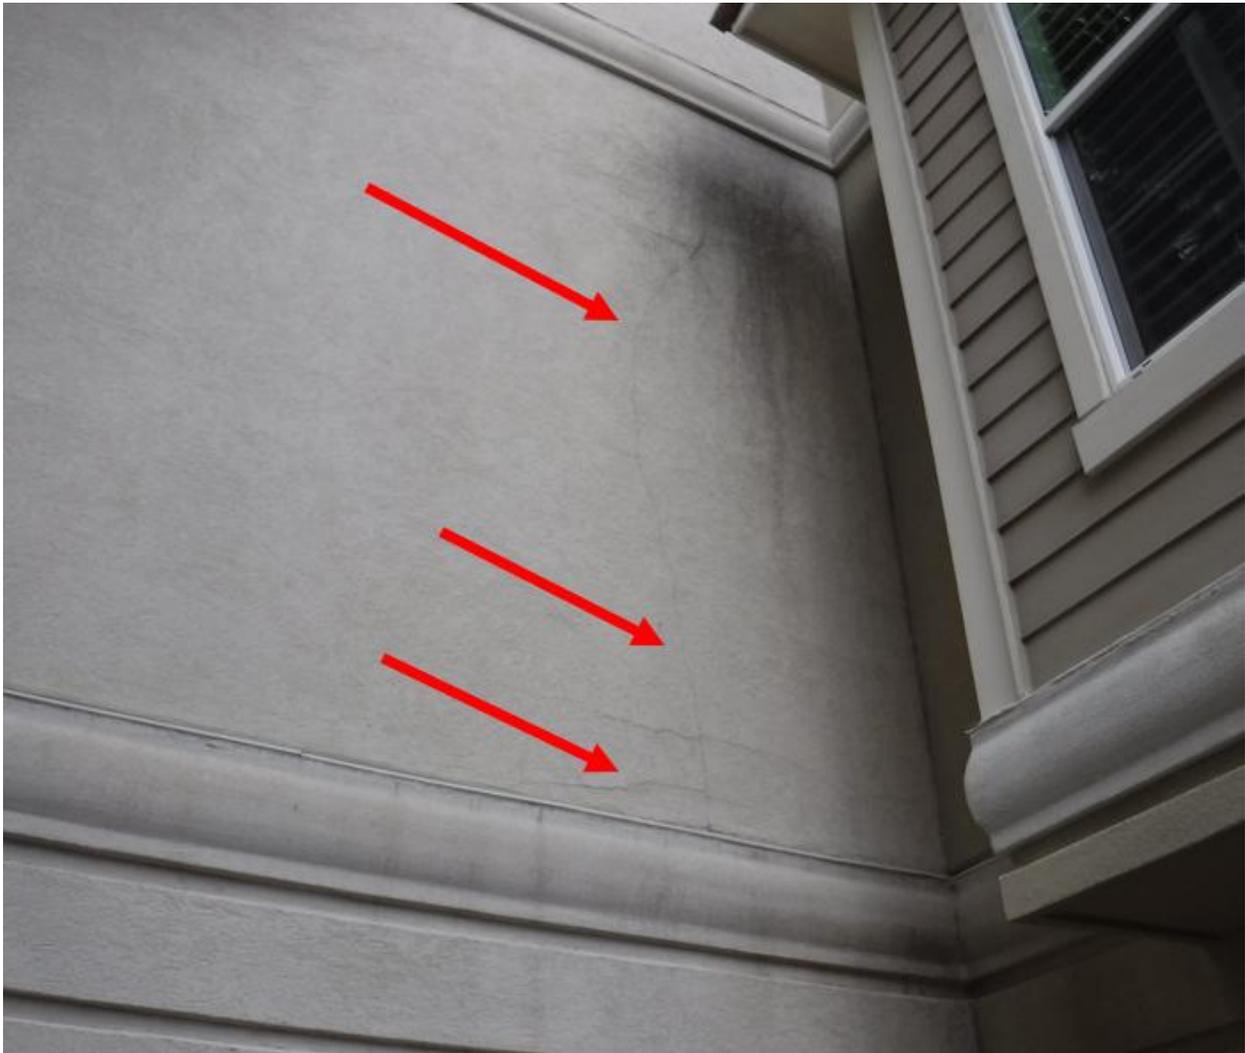
Exhibit 5.

Multiple “non-designed” cracks were observed in the exterior finish (Exhibit 5). Unrepaired cracks allow moisture to infiltrate behind the exterior finish. Once moisture is trapped behind the exterior finish, it creates an environment conducive to accelerated structural decay and an ideal habitat for subterranean termites. Measures should be taken to address these issues.

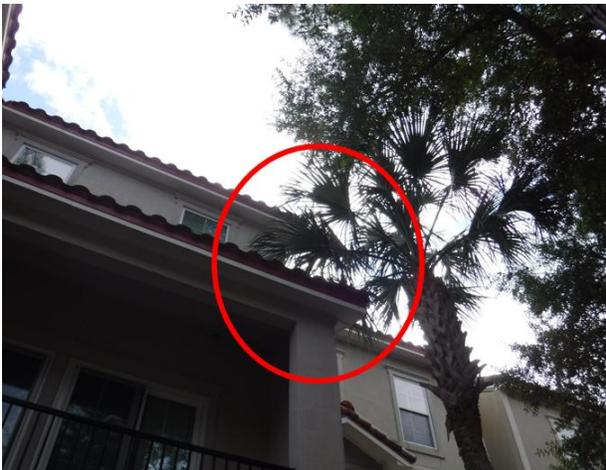
Exhibit 6.

Other conditions conducive to a subterranean termite infestation were discovered during this inspection. This included examples of trees and ornamentals located too close to structures (exhibits 6 and 7), soil and landscaping material at/or above the base of the exterior finish (exhibits 8 and 9), condensation/overflow piping terminating at the outer foundation wall (exhibit 10), and wood to ground contact (exhibit 11). Correction of these issues would include: ensuring at least 24 inches between the structure and the vegetation; at least a 6-inch “inspection” gap between the exterior finish and soil/landscaping material; at least a 12-inch termination of condensation/overflow piping away from the outer foundation wall; and correction of all wood to ground contact.

It is the opinion of this inspector that all conditions conducive to a subterranean termite described above should be corrected in conjunction with **a full conventional subterranean termite treatment**. The goal is to reduce the probability of future attacks by the WDOs observed during this inspection.
